# ANALYSIS OF SELECTED CUTTING INSERTS IN TERMS OF THEIR COMPOSITION AND WEAR

NATASA NAPRSTKOVA, JAROMIR CAIS, JAN SVIANTEK

Jan Evangelista Purkyně University  
Faculty of Production Technology and Management,  
Department of Technology and Material Science  
Usti nad Labem, Czech Republic

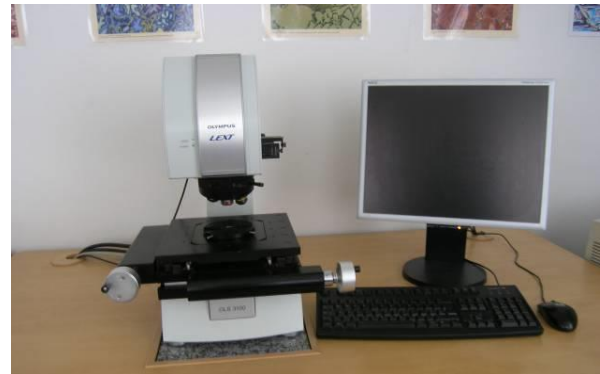
To verify the structure of the experimental material was made a microscopic analysis using a confocal laser microscope LEXT OLS 3100 (Fig. 1). [Kusmierczak 2011]

Figure 1. The laser confocal microscope LEXT OLS 3100

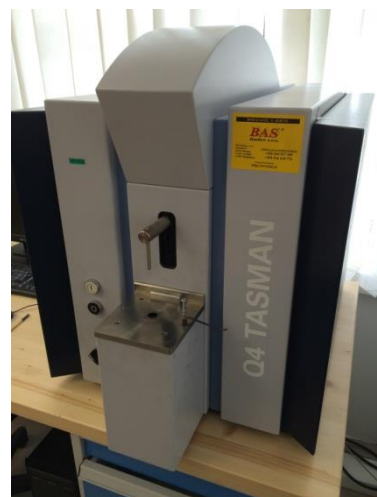
In Tab. 2 is the result of spectrometric analysis, which was performed using spark spectrometer Bruker Q4 TASMAN (Fig. 3). [Bruker 2016]

Figure 3. Spectrometer Q4 Tasman

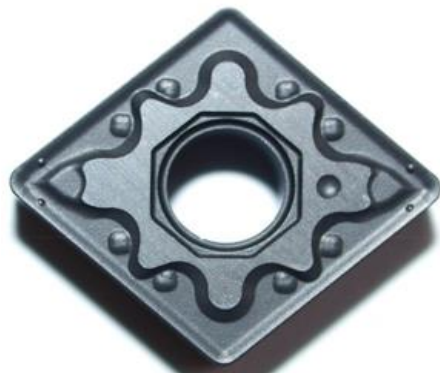
**Figure 5.** CNMG 120408-M KT-CTP15, Karned Tools s.r.o

For the analysis were delivered cutting insert (plate) CNMG 120408-M KT-CTP25 (Figure 4) and CNMG 120408-M KT-CTP15 (Figure 5), from company Karned Tools s.r.o. and CNMG 120408E-M GRADE T9325 (Figure 6) and CNMG 120408E-M GRADE T9315 (Figure 7), from company Pramet Tools s.r.o. [Hricova 2013, Kalincova 2014]

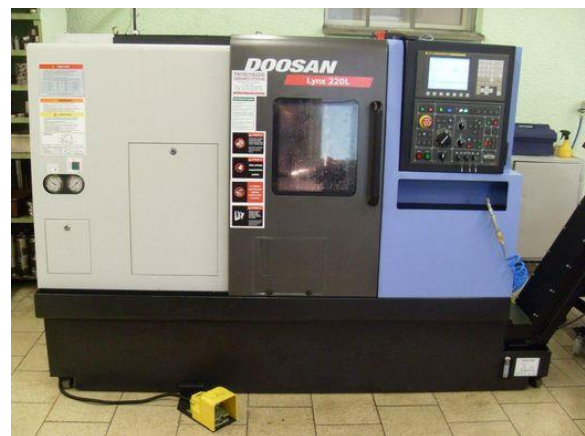
Experimental material was turning on the three-axis CNC lathe DOOSAN Lynx 220L with control system FANUC (Figure 8). [Kocman 2011]

**Figure 8.** CNC turning machine DOOSAN Lynx 220L

Cutting depth was determined as  $a_p = 1.5$  mm, because at indicative removal depth of 2 mm the whole system showed instability. Feed was set as  $f = 0,3$  mm.ot<sup>-1</sup>. For all investigated cutting inserts the same tool holder PCLNR 2020 K 12 was used. Experimental cutting speed was determined for all cutting inserts as  $v_c=80$  m.min<sup>-1</sup>,  $v_c=100$  m.min<sup>-1</sup>,  $v_c=120$  m.min<sup>-1</sup> and  $v_c=140$  m.min<sup>-1</sup>.

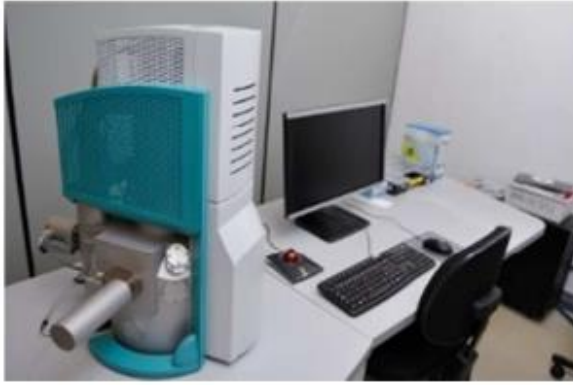
The first was conducted EDX analysis of the composition of experimental cutting inserts. For this purpose was used EDX analyzer Bruker 16 which is part of a scanning electron microscope Tescan Vega 3, which is on the FPTM JEPU available (Figure 9). [Cais 2015, Svobodova 2014]

Figure 9. Scanning electron microscope Tescan Vega 3

At all replaceable cutting inserts was performed SEM analysis of tool wear. The abbreviation SEM means a scanning electron microscope (Fig. 9). This microscope is working with a narrow electron beam. To create the image are used the primary and secondary electrons backscattered from the sample surface. These electrons formed by the interaction of atoms of the sample with electrons of the electron beam. Electrons detector receives and processes so as to obtain a sharp image of the sample surface. Rather than a traditional optical microscope is its advantage a large depth of sharpness and the ability to get more magnification. [Czajkowska 2013, ]
