# THE USE OF SEALANTS AS ONE OF THE METHODS OF REPAIRING LEAKS AND DAMAGED PIPE CLOSURES DURING OPERATION

ANTON PANDA, LUKAS ANDROVIC, IVETA PANDOVA

Technical University of Kosice, Department of Automotive and Manufacturing Technologies, Faculty of Manufacturing Technologies with a seat in Presov, Slovak Republic

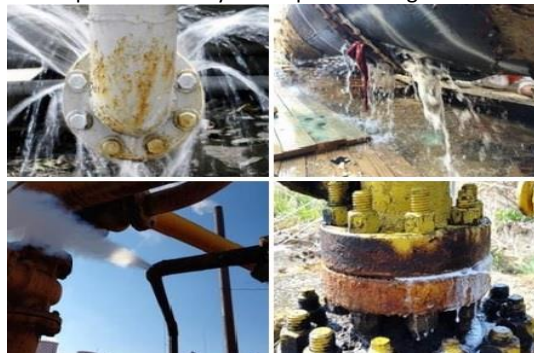
Figure 1. Different types of damage to the pipeline and its components [SEPS 2022]

The main goal of the pipeline operator is to operate the pipeline safely and especially profitably for a long time. However, during operation, the pipeline and its components are exposed to several negative influences, which result in the occurrence of various types of errors – see Fig. 1 [SEPS 2022].

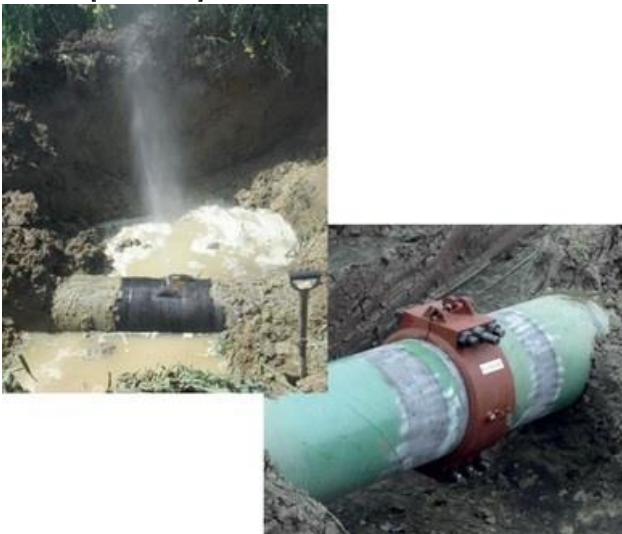
Figure 2. Pipe leak and split sleeve PLIDCO Split+Sleeve [SEPS 2022]

Figure 3. Pitting corrosion and sealing clamp PLIDCO Smith+Clamp [SEPS 2022]

One of the possible ways to solve the leak repair is to use a divided steel sleeve PLIDCO Split + sleeve (Fig. 2), which closes the leak in a safe way and ensures that the leak does not spread further into the surrounding area [SEPS 2022].

Another type of repair is the use of a sealing clamp PLIDCO Smith+Clamp (Fig. 3), which is used to repair separate spot leaks from the pipeline (Fig. 2), most often in places with pitting

corrosion. If the Smith+Clamp sealing clamp for permanent repair is used, the entire area including sealing cone will be covered with a PLIDCO Weld+Cap protective cap after the leak is closed [SEPS 2022].

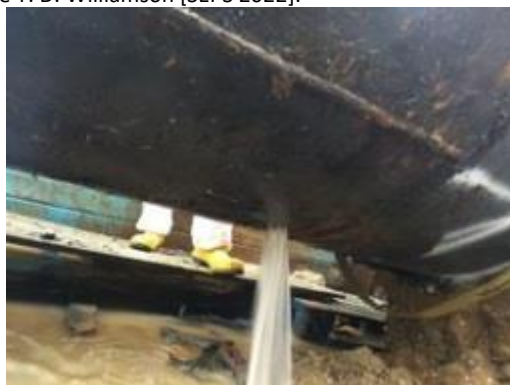
Figure 2. Water leak through a hole in a pipe [SEPS 2022]

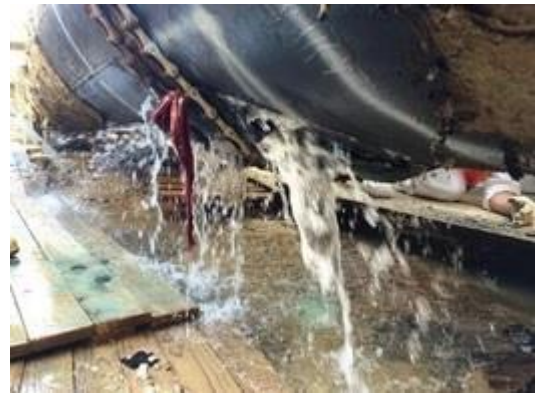
Figure 3. An unsuccessful attempt to stop the water leak by patch [SEPS 2022]

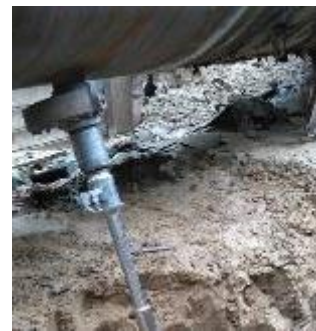
Figure 4. Insertion of the plug after the installation of a sleeve with a leak diversion [SEPS 2022]

In case of large diameter pipelines (Fig. 4 and 5), on which the use of split steel sleeves PLIDCO Split+Sleeve would be difficult, we use fully welded split steel sleeves with an outlet. After finishing the work, we insert under pressure into the outlet, which drains the leak, a special threaded plug with the drilling device T. D. Williamson [SEPS 2022].

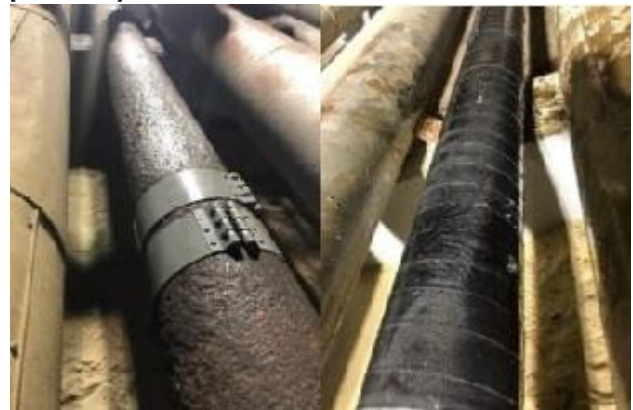
Figure 5. Stopping of the leak using a steel strap with a rubber seal [SEPS 2022]

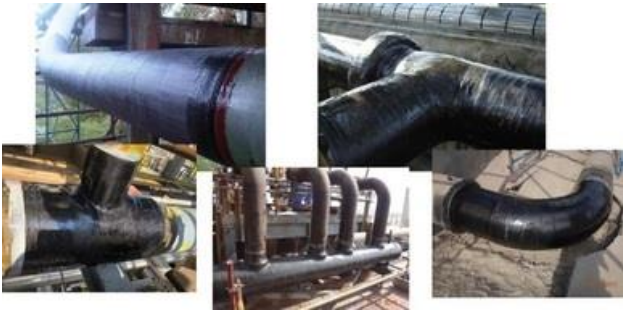
Figure 6. Composite bandage installation [SEPS 2022]

Pipe repair composite bandages (Fig. 8) use aluminum or glass fibers to reinforce the mechanical properties of the pipe (Fig. 6 and 7). The fibers transmit and absorb the strains (tensions) caused by a pipe fault. Thanks to their flexibility, they are suitable for repairs of broken pipe objects such as branches, elbows, etc. [SEPS 2022].

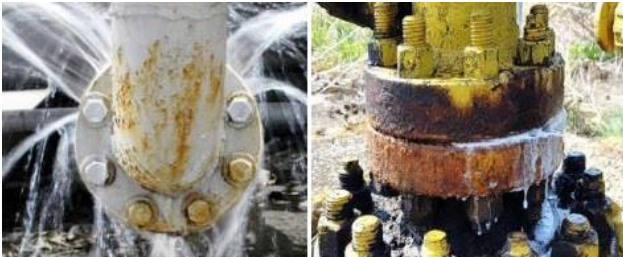
Figure 7. Leaks at flange joints [SEPS 2022]

One of the most important elements of the pipeline are its joints (Fig. 9). Joints could be welded or flanged.

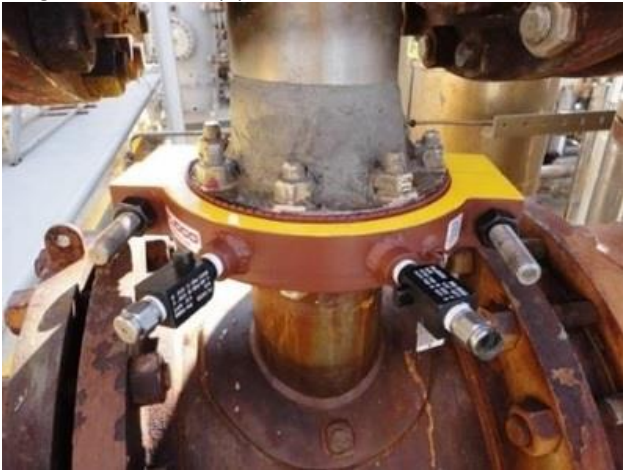
Figure 8. PLIDCO Flange Repair+Ring flange sealing ring [SEPS 2022]

We use the PLIDCO Flange+Repair Ring (Figs. 10 and 12) to seal the leaks at the flange joints. Repair of leaks on the flange joint is very fast, without the need to drill into the flanges, thanks to which none of the original material is destroyed. At the earliest pipe shut down, just remove the ring, replace the seal on the flange and restart the pipeline [SEPS 2022].

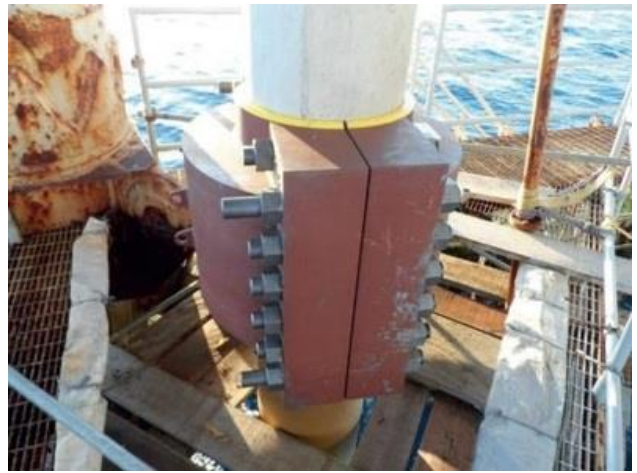
Figure 9. PLIDCO Flange Repair Split+Sleeve flange reinforcement sleeve [SEPS 2022]

We use PLIDCO Flange Repair Split+Sleeve (Fig. 11), in case of leaks found on circumferential welds of the pipe flange, or in case of damage to the entire flange [SEPS 2022].

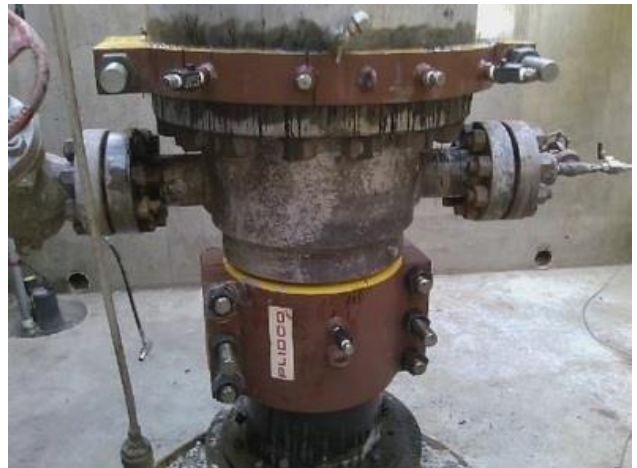
Figure 10. Flange joint leak stop [SEPS 2022]

After installing the ring on the flange joint, using a filling pump, a sealing compound is pressed through the filling valves (Fig. 13) into the intermediate space of the ring and the flange joint, which seals the leakage and prevents the medium from escaping [SEPS 2022].

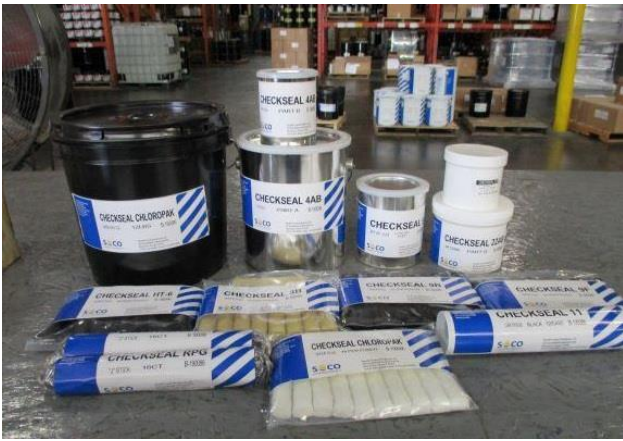
Figure 12. CHECK SEAL sealants to seal the leaks [SEPS 2022]

Thanks to their properties, these sealants (Fig. 14) are able to seal leaks of known chemical substances up to a temperature of +815' C and can fully replace the sealants of other manufacturers, such as FURMANITE. SOCO Company is not only a manufacturer of "sealant", but also a provider of compete know-how for correct, high quality and safe sealing of operation leaks [SEPS 2022].

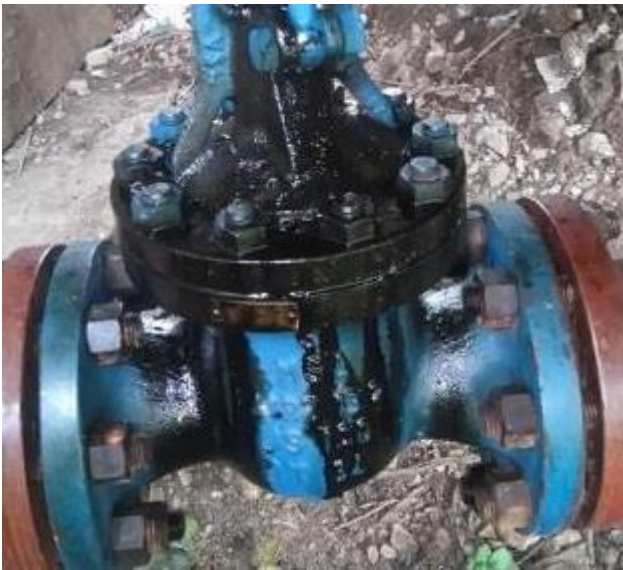
Figure 13. Leak outside the closure [SEPS 2022]

In most cases, leaks outside the closure (Fig. 15) can only be solved by replacements. If it is not possible to shut down the pipeline, we use one of the "non-stop" technologies T. D. Williamson (Figs. 19 and 20), or PLIDCO Shear+Plug (Figs. 21 and 22) [SEPS 2022].

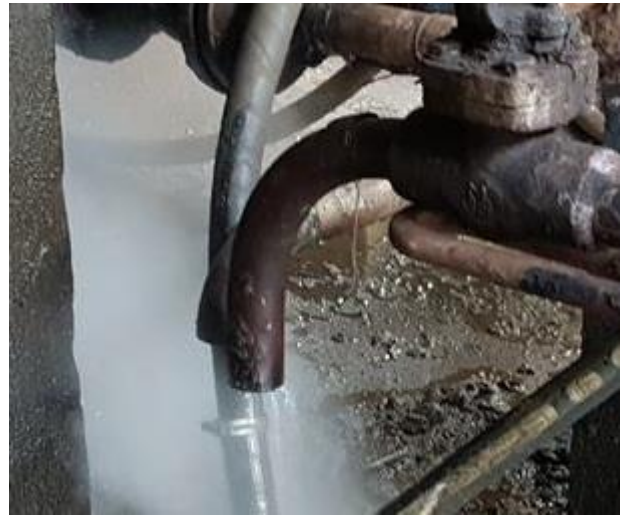
Figure 14. Leak through the closure [SEPS 2022]

*Leakage of the product through (Fig. 16) the sealing element of the closure (cone, ball, plate, flap, etc.) can be repaired in principle in two possible ways:*

- 1) by replacing the closure during operation using the same closing device like in the previous chapter (3.1.),
- 2) by closing the free end and pressing the sealant into it.

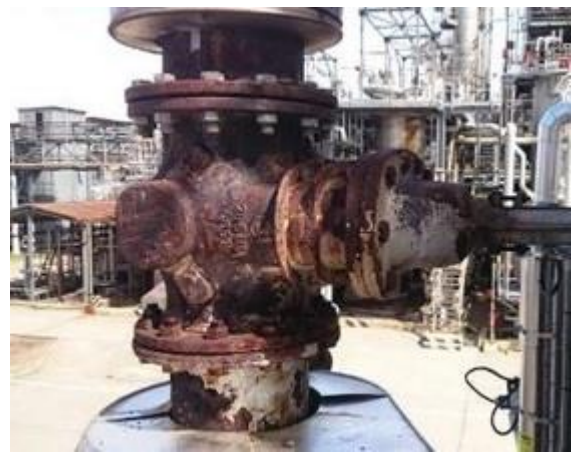
Figure 15. Torn off plate of the closure [SEPS 2022]

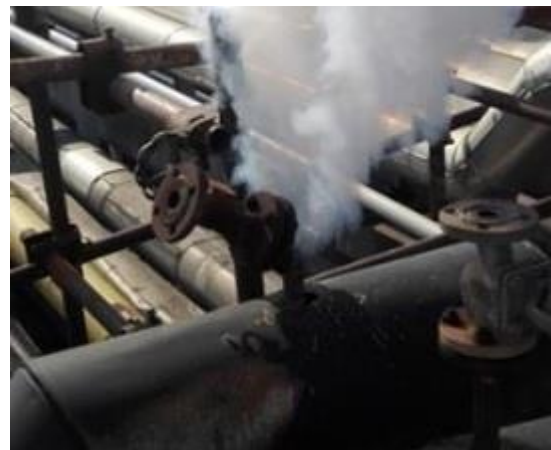
Figure 16. Torn off closure [SEPS 2022]

One of the most problematic repairs is the tearing off the closure in the weld (Fig. 28). Such a problem usually ends with the shutdown of the pipeline and thus the relevant technology. However, this damage (Fig. 17 and 18) can be solved by repairing the pipeline during operation by closing the piping like in the previous chapter (3.1.), or by installing a special sleeve with the neck and exhaust (Figs. 29 and 30). In this case, the repair ended with insertion of a special threaded plug T. D. Williamson during operation (during leaking) and by fitting a threaded protective cap (Fig. 30) [SEPS 2022].

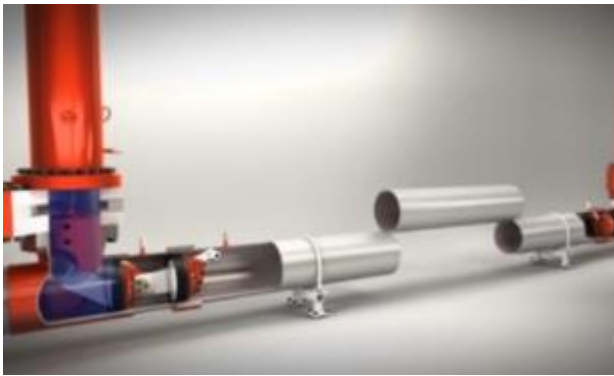
**Figure 17.** Two-position closing operation with STOPPLE Train [SEPS 2022]

The T. D. Williamson method makes it possible to carry out pipe line repairs, reconstructions, change of pipeline route, connection of other technology to the main pipe line, but especially replacement of the non-compliant pipe line parts, non-compliant closures, replacement of technological pipeline components, tanks and pressure vessels, as well as other specific activities during the pipeline system operation [SEPS 2022].

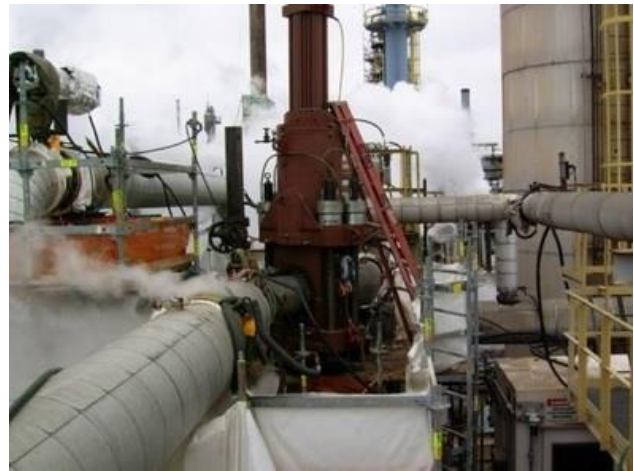
**Figure 20.** Steam line closure DN350 [SEPS 2022]

If it is necessary to close the pipeline at high temperatures up to 537° C or at high pressure up to 170 bar (17,0 MPa), the PLIDCO Shear+Plug closing device can be used (Figs. 21 and 22). This device is used to close pipes with a diameter from DN20 up to DN450 [SEPS 2022].

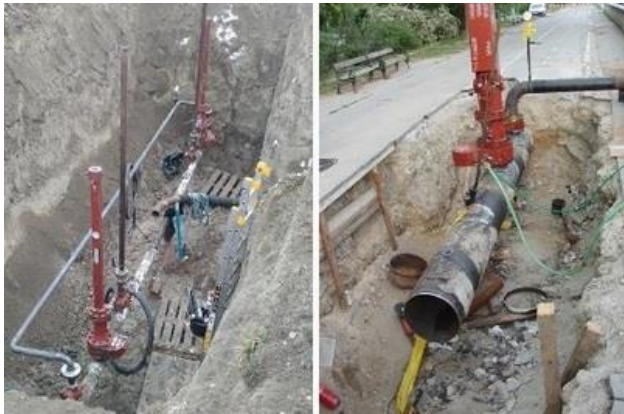
**Figure 18.** Use of bypass in case of a need of continuous supply of product in a pipeline [SEPS 2022]

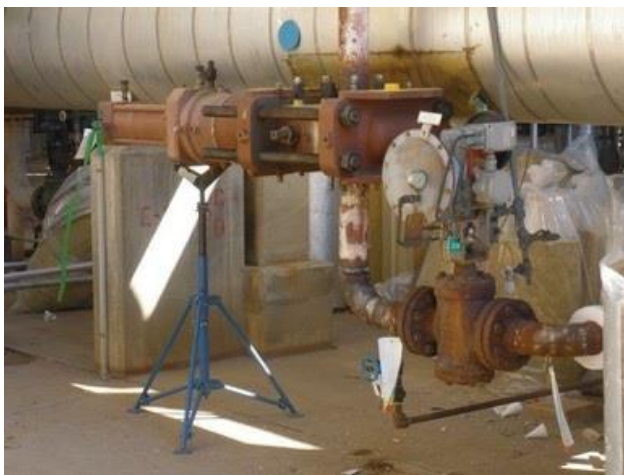
**Figure 19.** Boiler water pipe closure (Boiled Feed Water) DN80 [SEPS 2022]

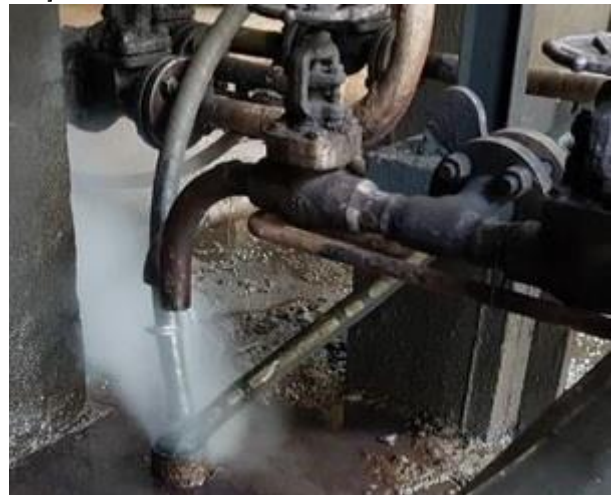
**Figure 21.** Closure leak DN50 [SEPS 2022]

In this case (Figs. 23 and 24) we used an assembled pipe coupling (adapter) PLIDCO Weld+End. We closed the adapter at the bottom with a neck with a connection for pressing a sealant into it and slid it on the other side to the end of the pipe with the product leak. After securing the mounting screws and sealing the leak into the environment with the help of pressure screws which expanded the seal and thus sealed the leak, we pressed in the sealer and sealed off the leaking product [SEPS 2022].

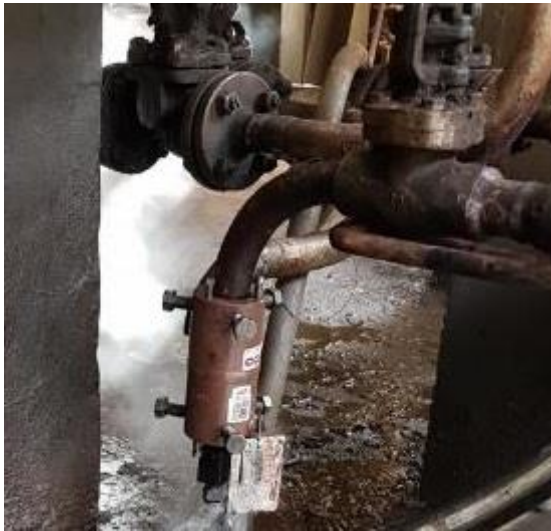
**Figure 22.** Stopping leakage using PLIDCO Weld+End blanking sleeve [SEPS 2022]

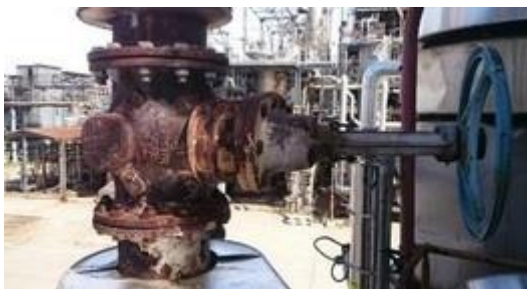
**Figure 23.** Torn off spindle of the closure plate in a closed position [SEPS 2022]

If the integrity of the spindle of the closure is compromised due to the physical and chemical factors of the product inside the closure, the spindle often tears off and thus the closure cannot be operated [SEPS 2022].

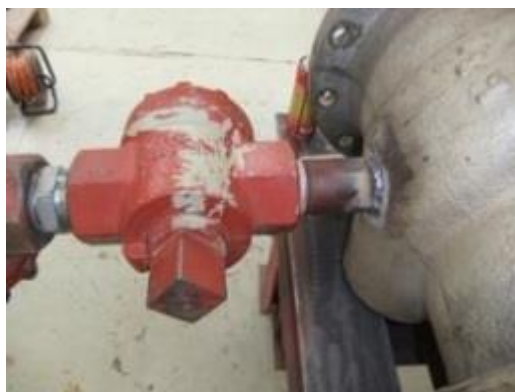
**Figure 24.** Welding the throat on and drilling through it during operation [SEPS 2022]

In this case (Fig. 25), the spindle tore off, the plate remained in the closed position and it was not possible to open it, causing the flow in the pipeline to be interrupted. On a similar old closure, which was provided to us by the operator for testing, we proposed a method of welding the drill neck to the pipeline during operation. After welding and performing all the necessary flaw detection tests, we proceeded to welding and subsequent drilling modeling of the closure during operation (Fig. 26). After successfully performing all tests in the workshop, we welded a drill neck in the lower part of the closure and drilled an access opening into the body all during operation. After drilling, we then moved away the plate using a rod installed on the shaft of the drill (Fig. 27) and during operation we opened the closure, which cleared the pipeline route, so the operator did not have to shut down a given part of technology [SEPS 2022].

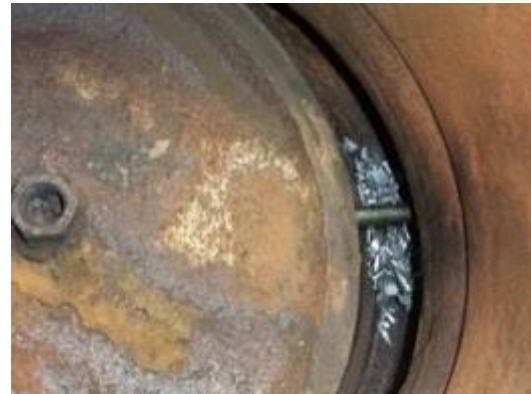
**Figure 25.** Pushing the closure plate out of the closed position [SEPS 2022]

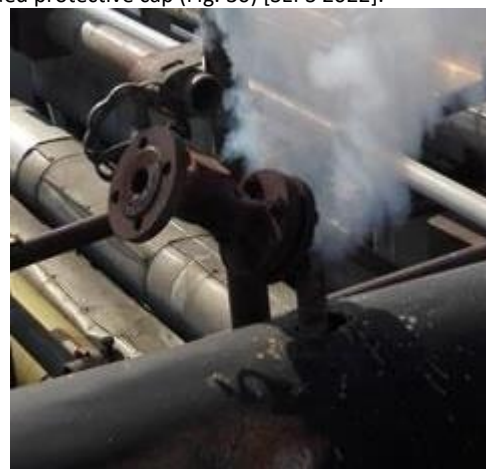
**Figure 26.** Torn off closure of the steam line in the weld under the flange [SEPS 2022]

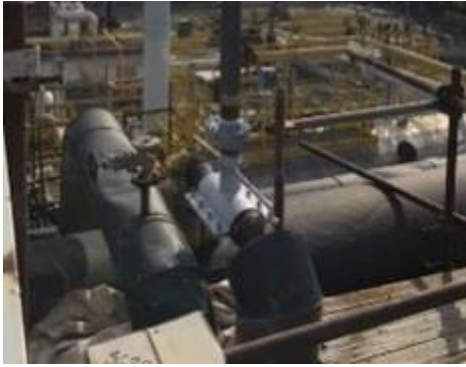
**Figure 27.** Installation of the sleeve with throat and exhaust [SEPS 2022]

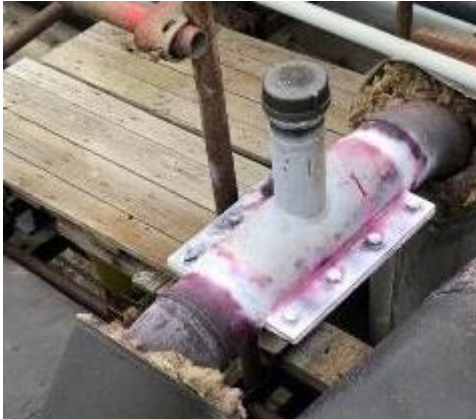
**Figure 28.** Sleeve with a throat after the works finish during operation [SEPS 2022]
